UNITED STATES DISTRICT COURT  
EASTERN DISTRICT OF MISSOURI  
EASTERN DIVISION

FRED NEKOUEE, individually, :  
: Plaintiff, :  
: vs. : Case No. 4:19-cv-0191  
: IWALA INC., :  
: a Missouri corporation, :  
: Defendant. :  
: /

**COMPLAINT**  
(Injunctive Relief Demanded)

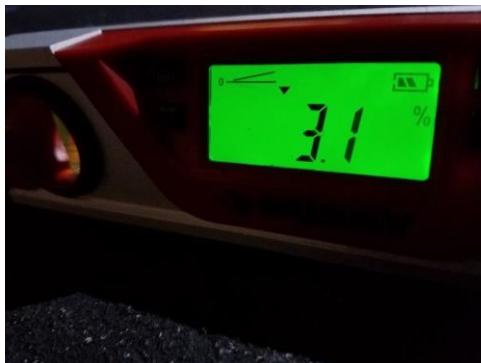
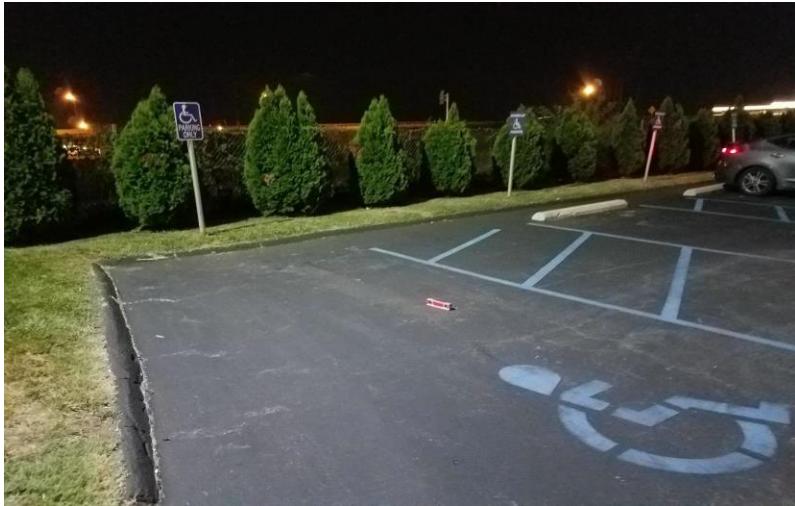
b. (i) In the parking lot, the middle section of the parking space for disabled patrons shown in the photograph below has a running slope as steep as about 1:32.3 (3.1%) and steeper than a slope of 1:48 (2%). (ii) This running slope is steeper than the maximum allowed slope of 1:48 (2%), in violation of Federal Law 2010, ADAAG § 502.4. (iii) The Plaintiff observed this slope, and it deters him from visiting Best Western Plus. (iv) The action required to make this parking space level is easily accomplishable and able to be carried out without much difficulty or expense.

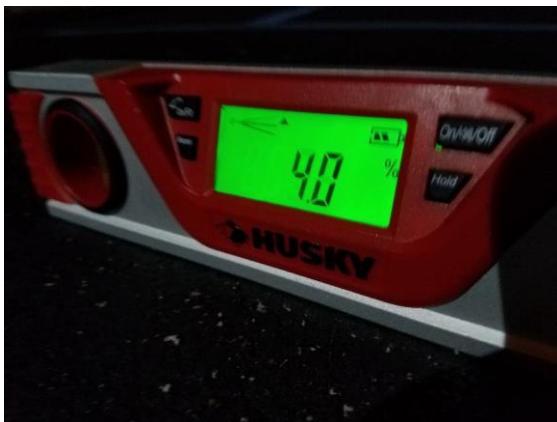
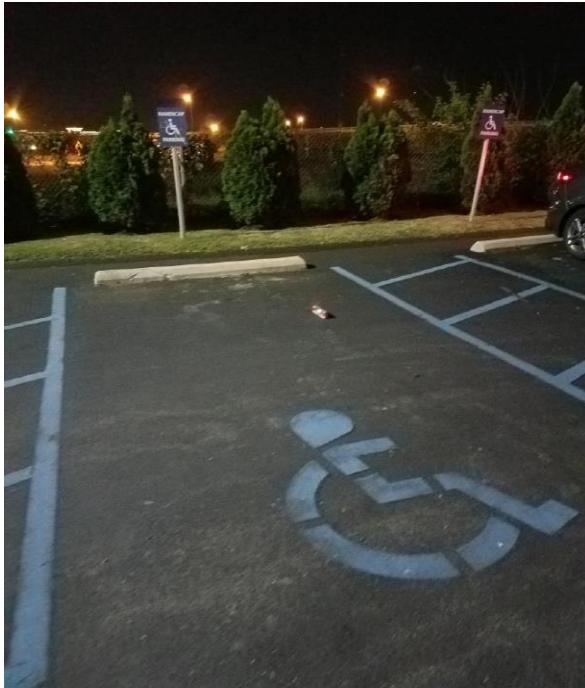
c. (i) In the parking lot, the front section of the parking space (oriented closest to the sign) for disabled patrons shown in the photograph below has a running slope as steep as about 1:25 (4%) and steeper than a slope of 1:48 (2%). (ii) This running slope is steeper than the maximum allowed slope of 1:48 (2%), in violation of Federal Law 2010, ADAAG § 502.4. (iii) While moving in his wheelchair, the Plaintiff encountered this slope and it made his wheelchair unstable. (iv) The action required to make this parking space level is easily accomplishable and able to be carried out without much difficulty or expense.

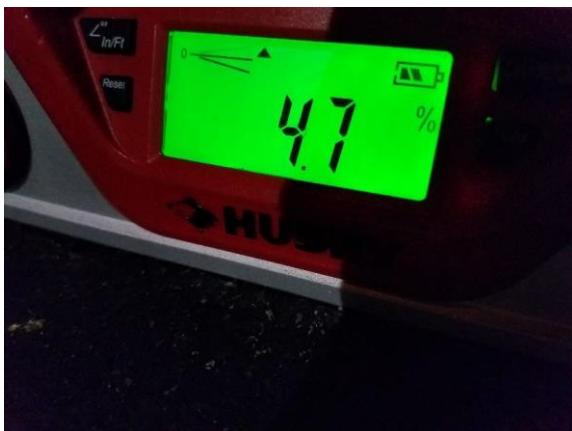
d. (i) In the parking lot, the front section of the parking space (closest to the sign) for disabled patrons shown in the photograph below has a running slope as steep as about 1:21.3 (4.7%) and steeper than a slope of 1:48 (2%). (ii) This running slope is steeper than the maximum allowed slope of 1:48 (2%), in violation of Federal Law 2010, ADAAG § 502.4. (iii) The Plaintiff encountered this slope, and it made his wheelchair unstable. (iv) The action required to make this parking space level is easily accomplishable and able to be carried out without much difficulty or expense.

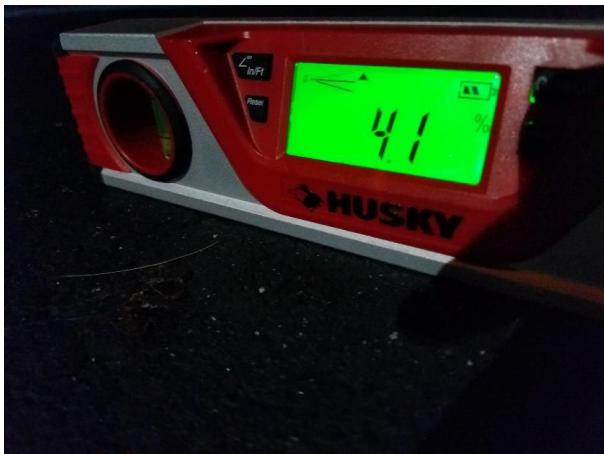
f. (i) In the parking lot, the running slope of the front section of the access aisle (oriented closest to the sign) serving the parking spaces for disabled patrons shown in the photograph below is as steep as about 1:24.4 (4.1%) and steeper than a slope of 1:48 (2%) and its back section has a running slope as steep as about 1:32.3 (3.1%) and steeper than a slope of 1:48 (2%). (ii) These running slopes in this access aisle are steeper than the

maximum allowed slope of 1:48 (2%), in violation of Federal Law 2010, ADAAG § 502.4.

(iii) While moving in his wheelchair, the Plaintiff encountered these slopes, and it made his wheelchair unstable, and he required assistance to ascend this access aisle in his wheelchair. (iv) The action required to make this access aisle level is easily accomplishable and able to be carried out without much difficulty or expense.

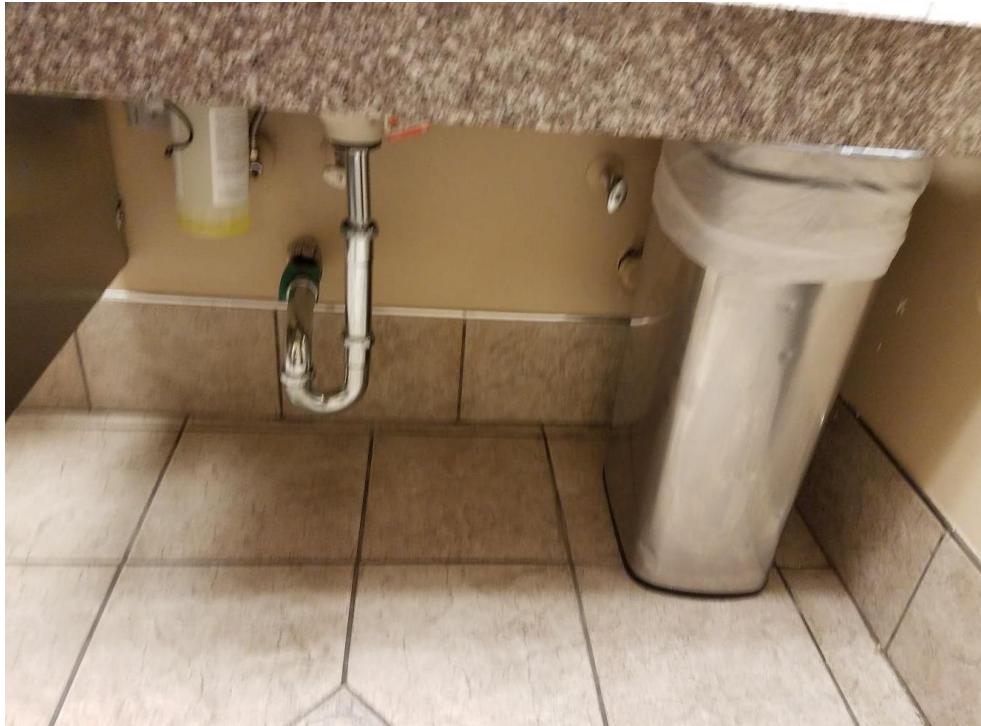
t. (i) In the men's restroom in the lobby, as shown in the photograph below, the lavatory pipes under the sink are not insulated. (ii) These lavatory pipes under the sink are not insulated, in violation of Federal Law 2010, ADAAG § 606.3. (iii) Due to this lack of insulation on these pipes, the Plaintiff risked burns to the skin on his legs and injury when he used this sink from his wheelchair. (iv) The action required to insulate these pipes under the sink is easily accomplishable and able to be carried out without much difficulty or expense.

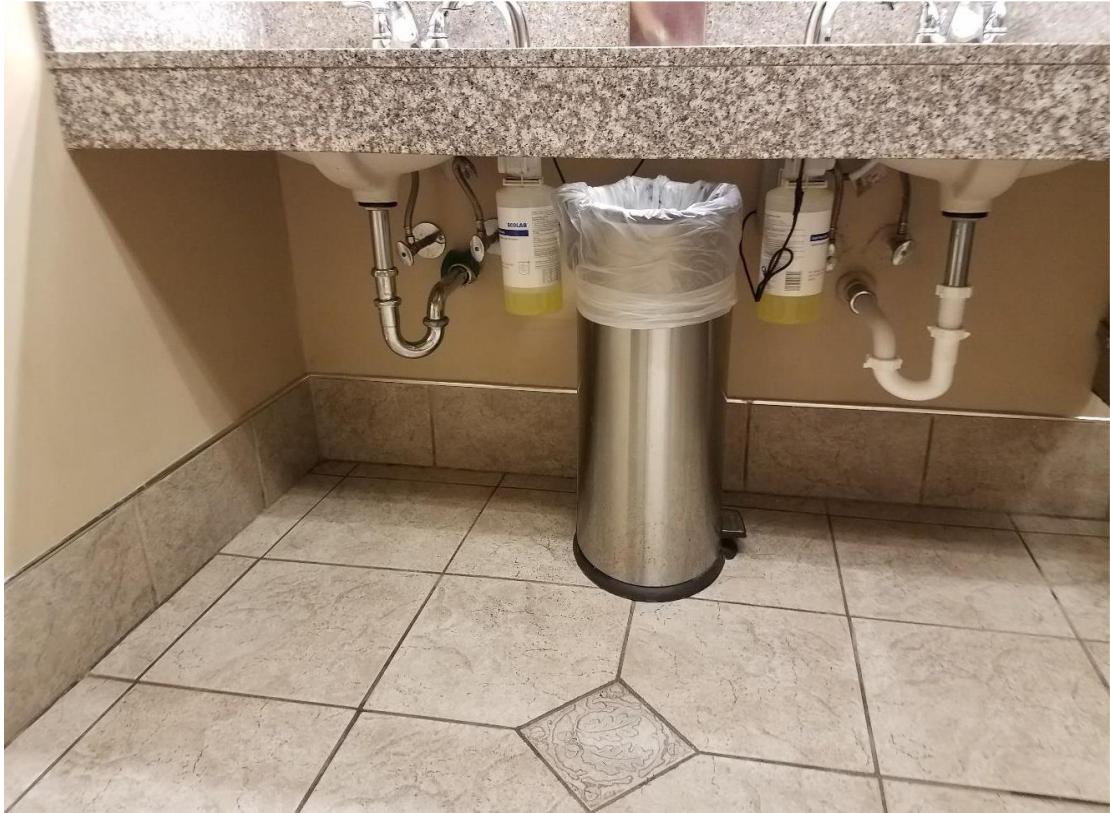
ll. (i) In the women's restroom in the lobby, the lavatory pipes under the sinks are not insulated as shown in the photograph below. (ii) The lavatory pipes under these sinks are not insulated, in violation of Federal Law 2010, ADAAG §§ 606.3 and 606.5. (iii)

The Plaintiff observed the lack of insulation on the lavatory pipes under these sinks and it deters him from visiting Best Western Plus and risking skin burns and injury to his legs.

(iv) The action required to insulate the lavatory pipes under these sinks is easily accomplishable and able to be carried out without much difficulty or expense.
